U.S. Department  
of Transportation

National Highway  
Traffic Safety  
Administration

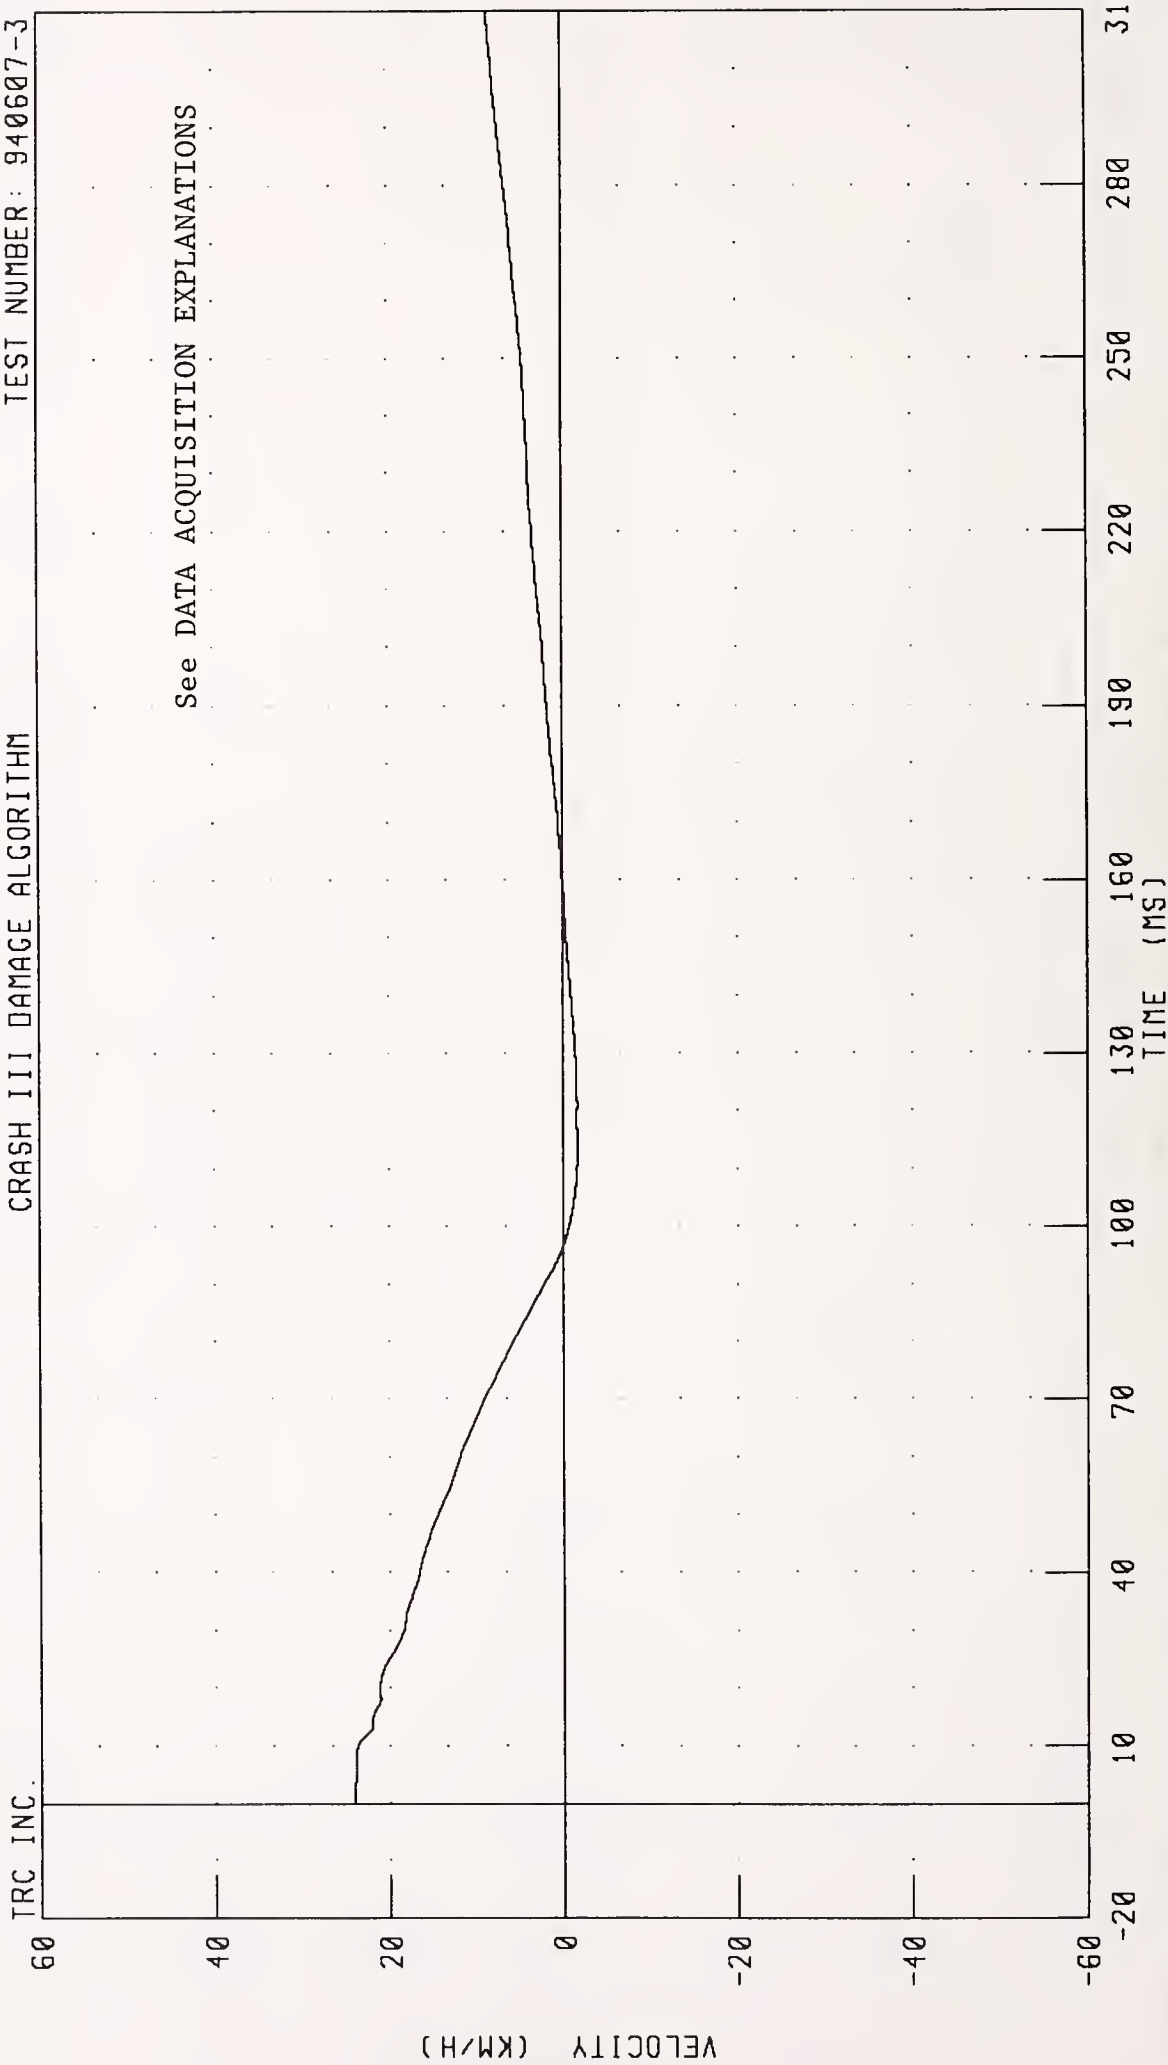
CHANNEL: LRSXV1 FILTER: CH. CLASS 180

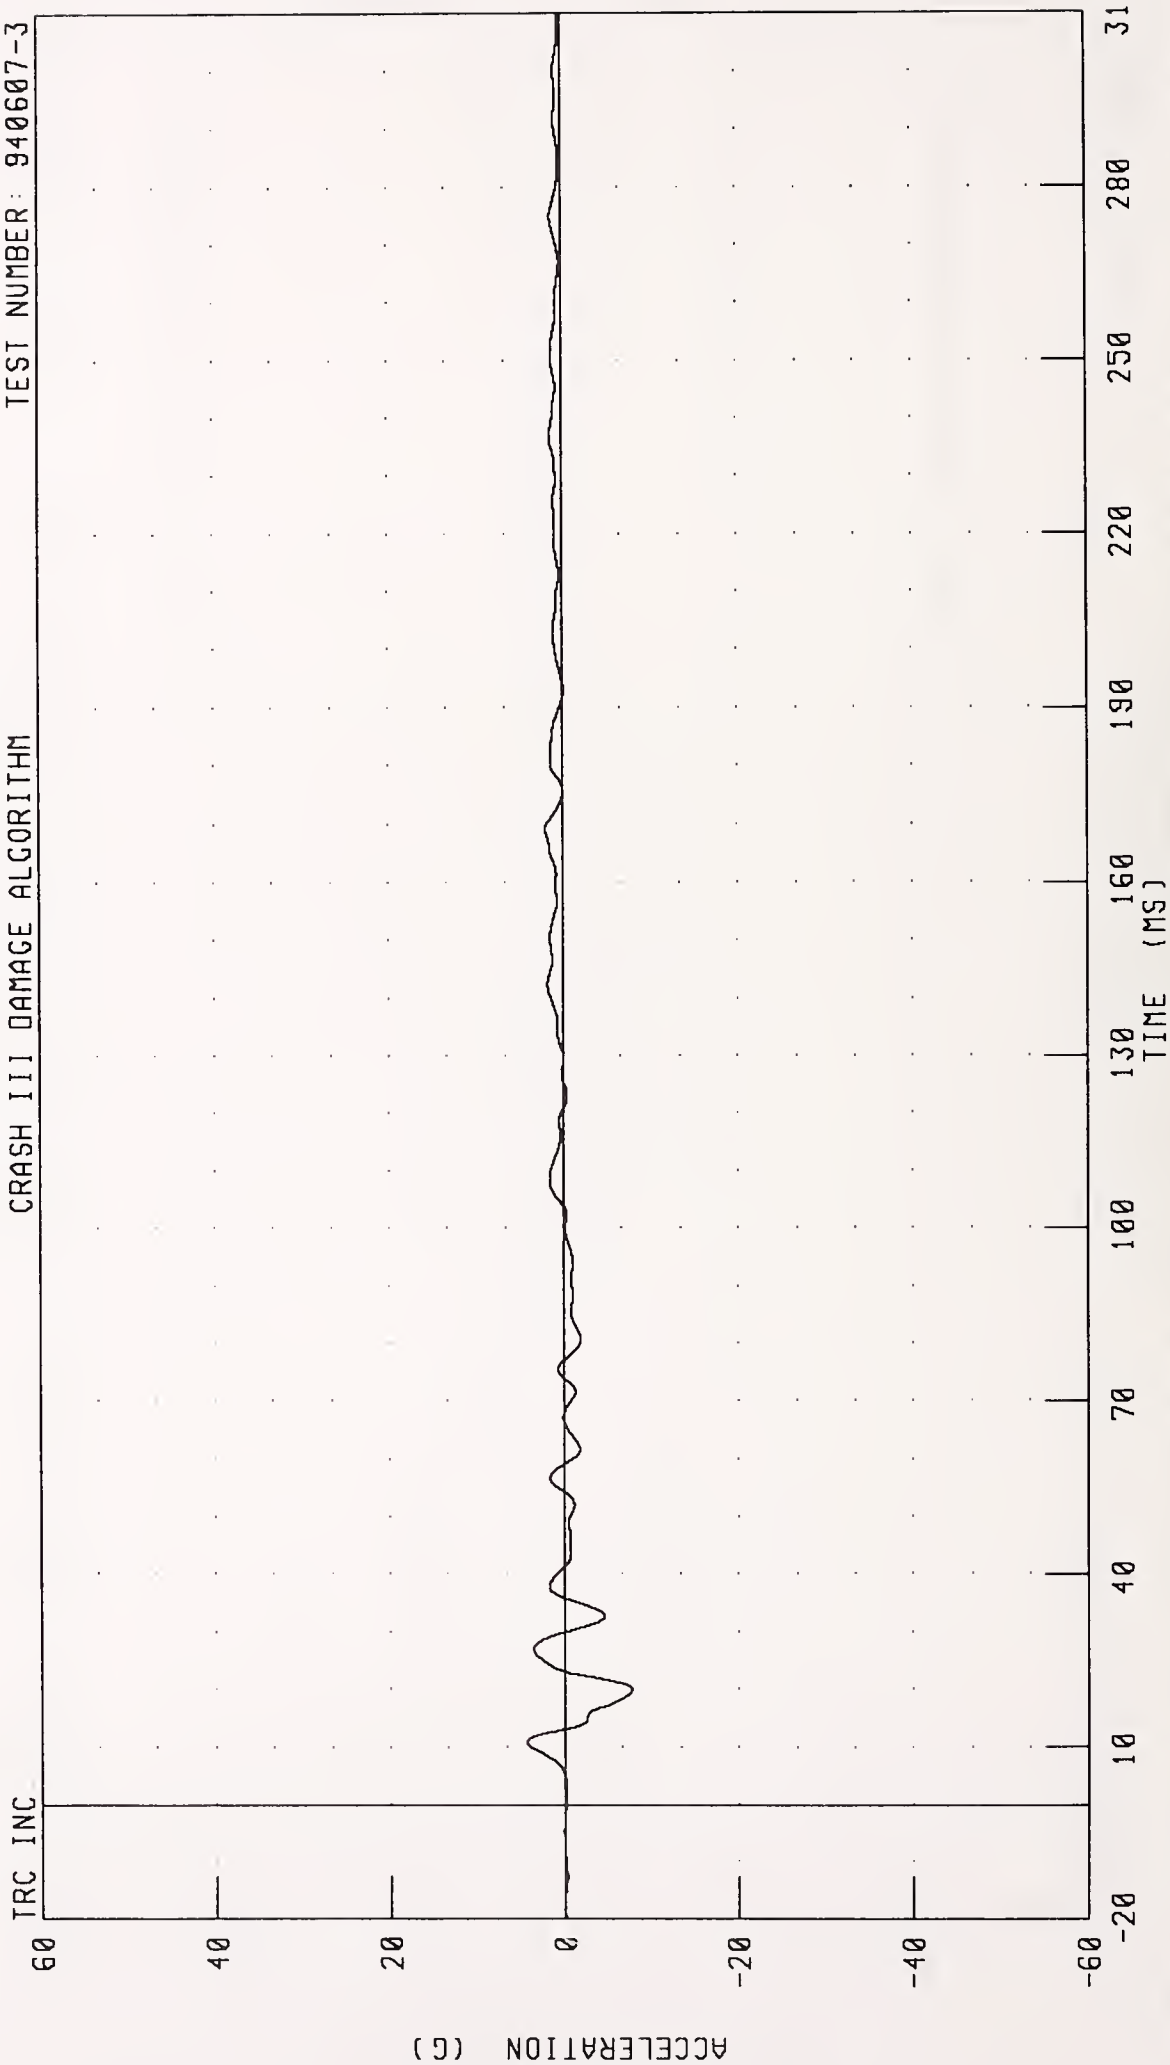
CHANNEL: LRSYG1 FILTER: CH. CLASS 60

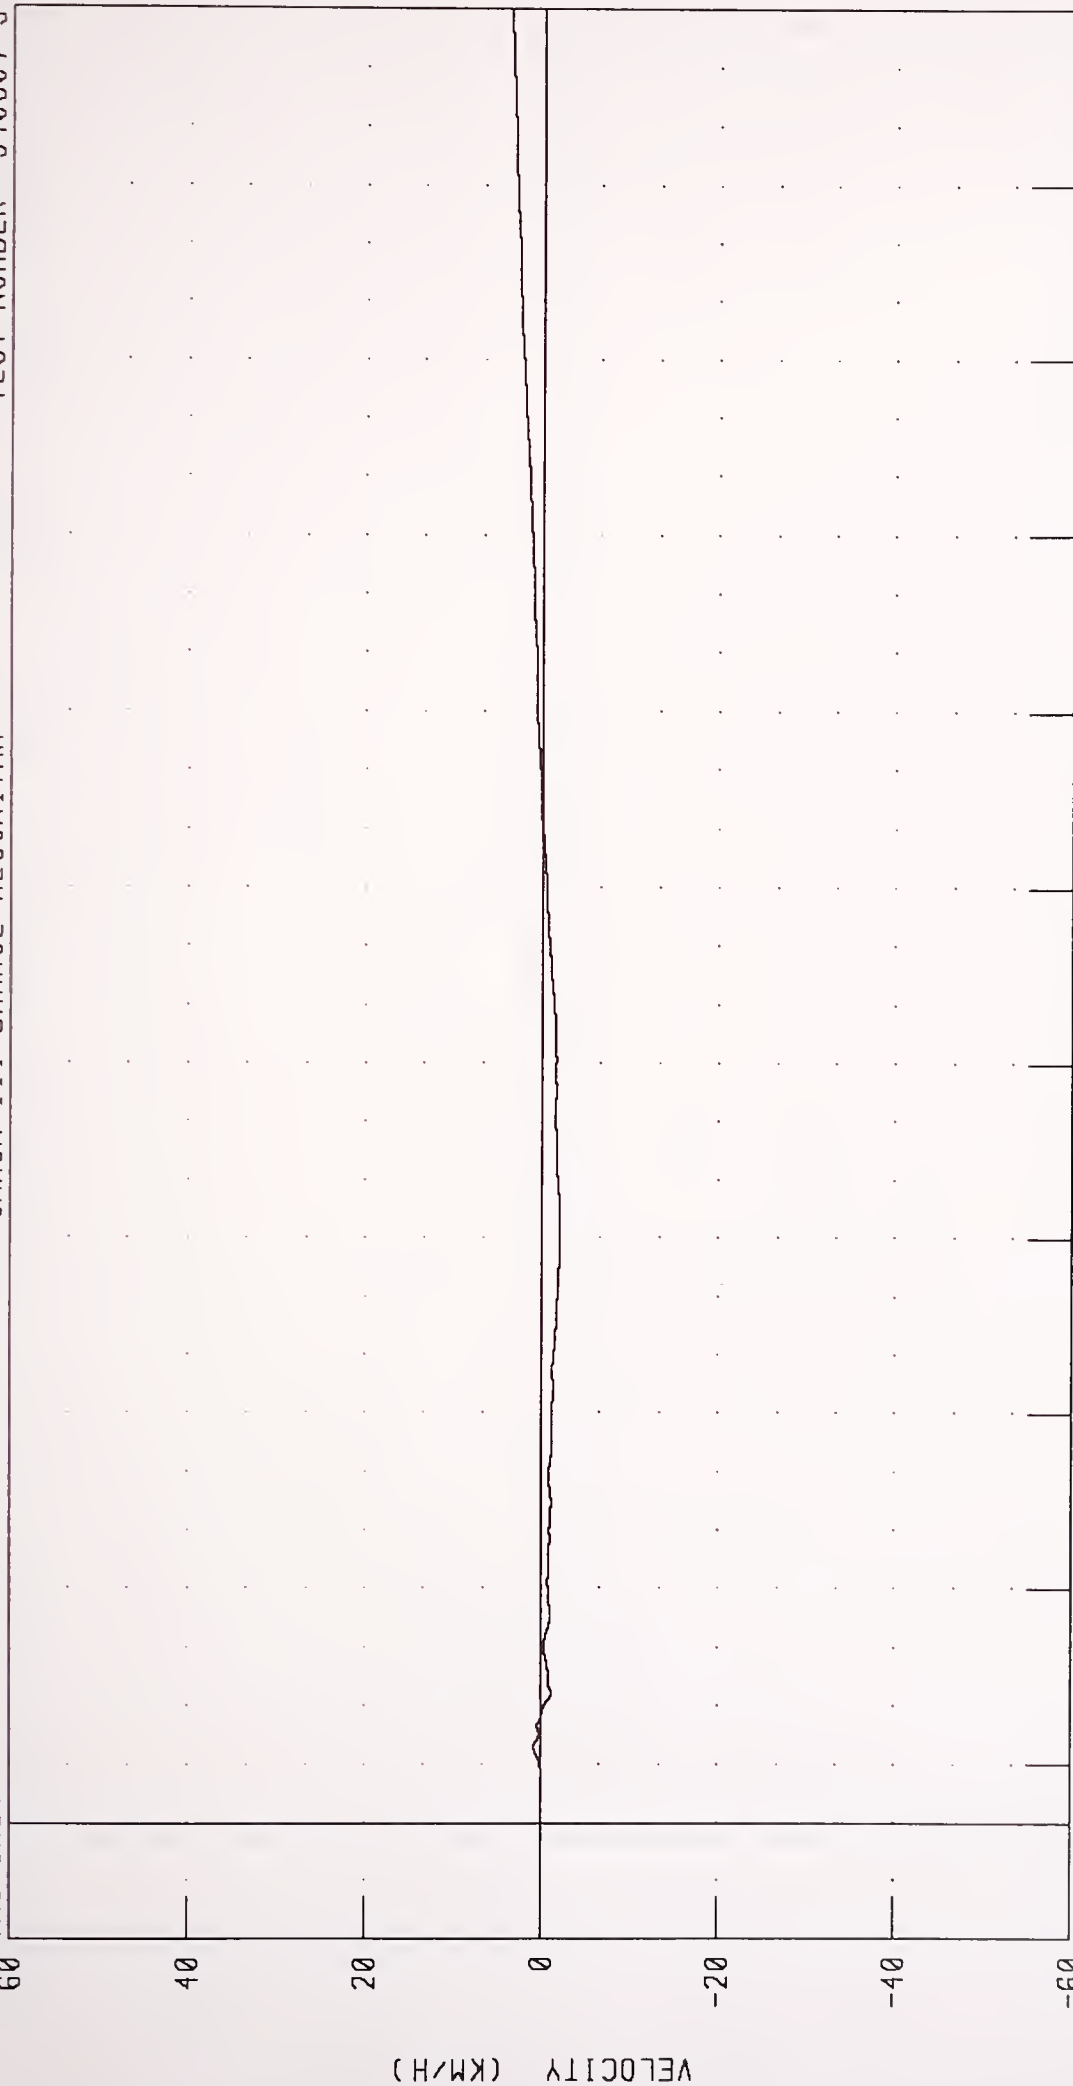
CHANNEL: LRSYV1 FILTER: CH. CLASS 180  
PEAK DATA: 3.70 KM/H @ 310.00 MS; -2.08 KM/H @ 104.24 MS

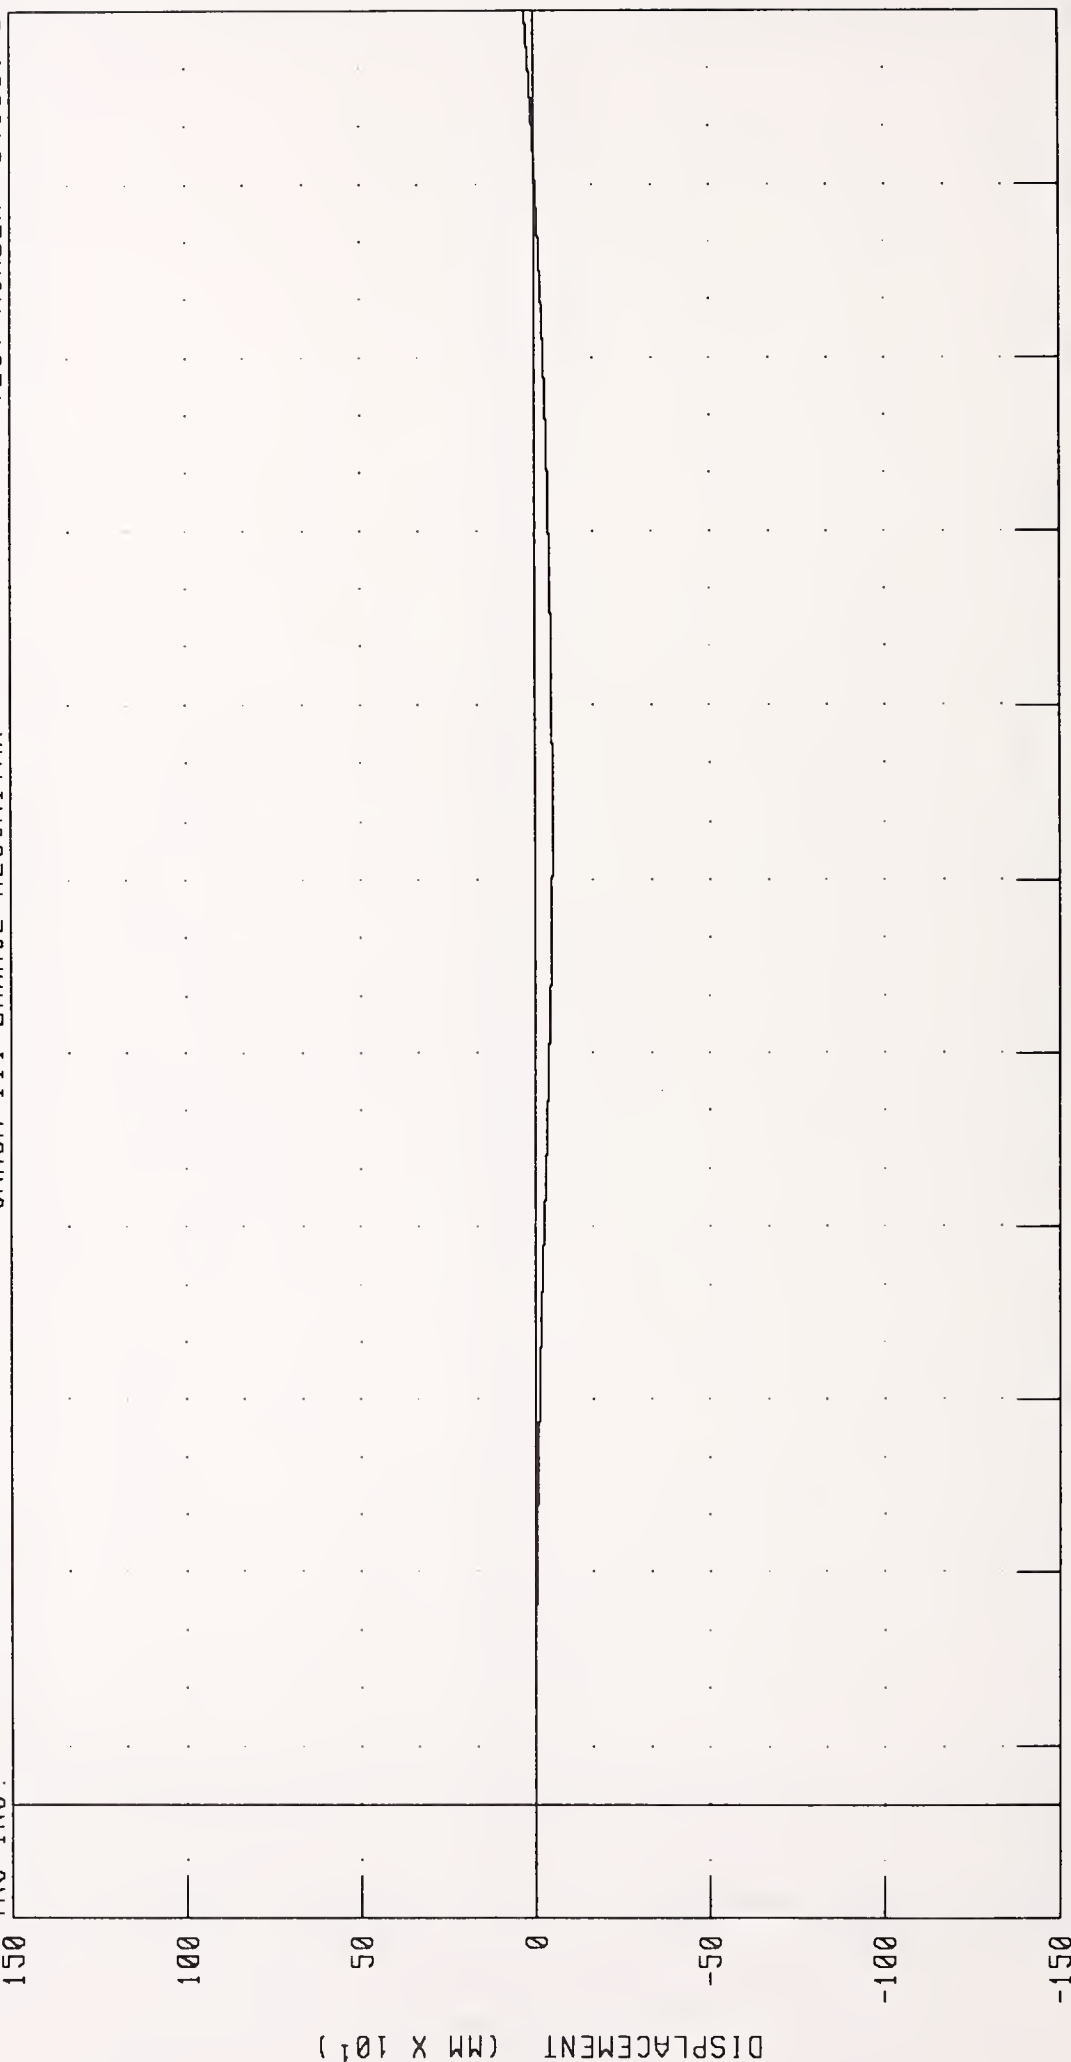
CHANNEL: LRSYD1 FILTER: CH. CLASS 180

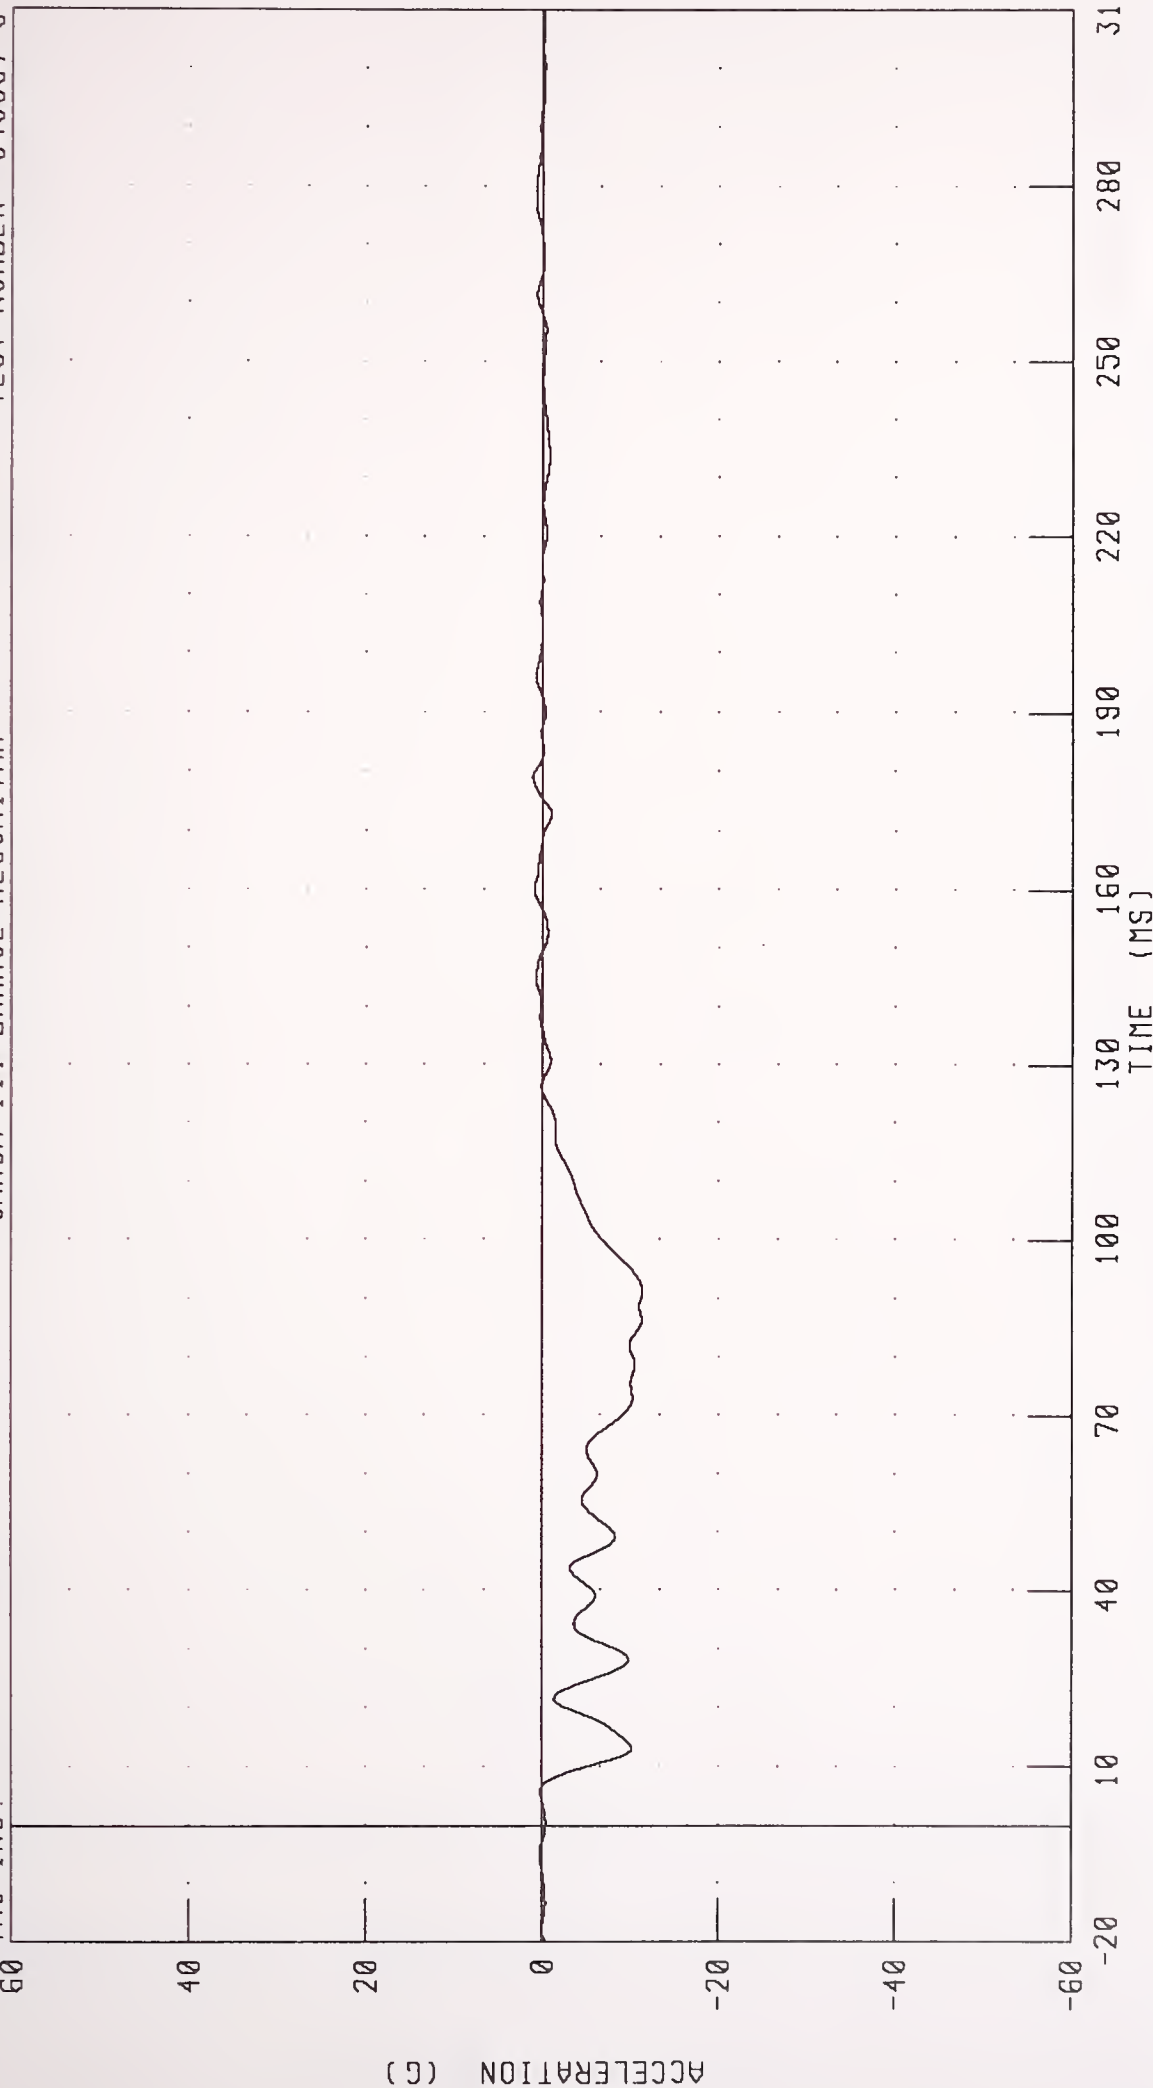
CHANNEL: RRSXG1 FILTER: CH. CLASS 60

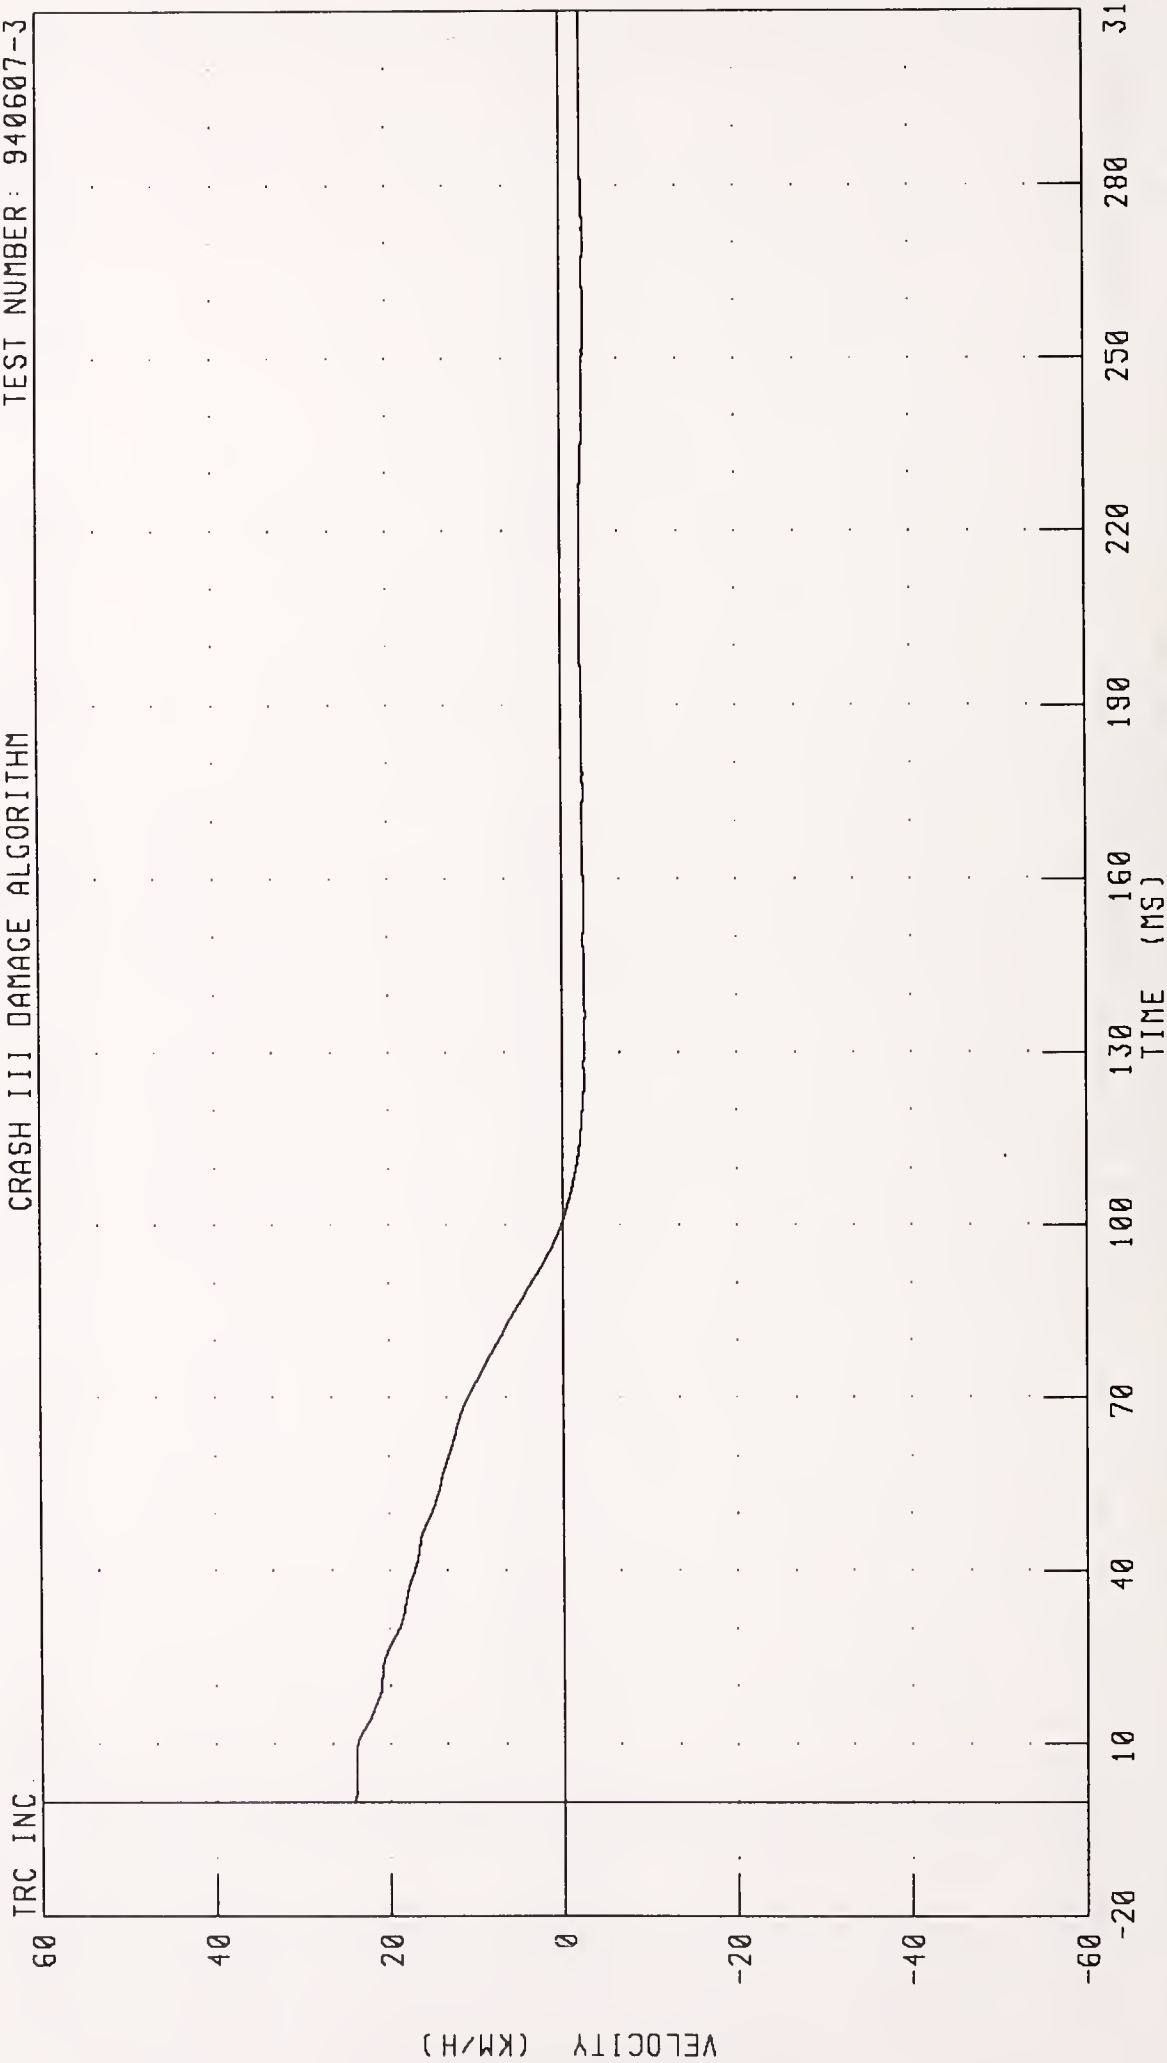
CHANNEL: RRSXV1 FILTER: CH. CLASS 180

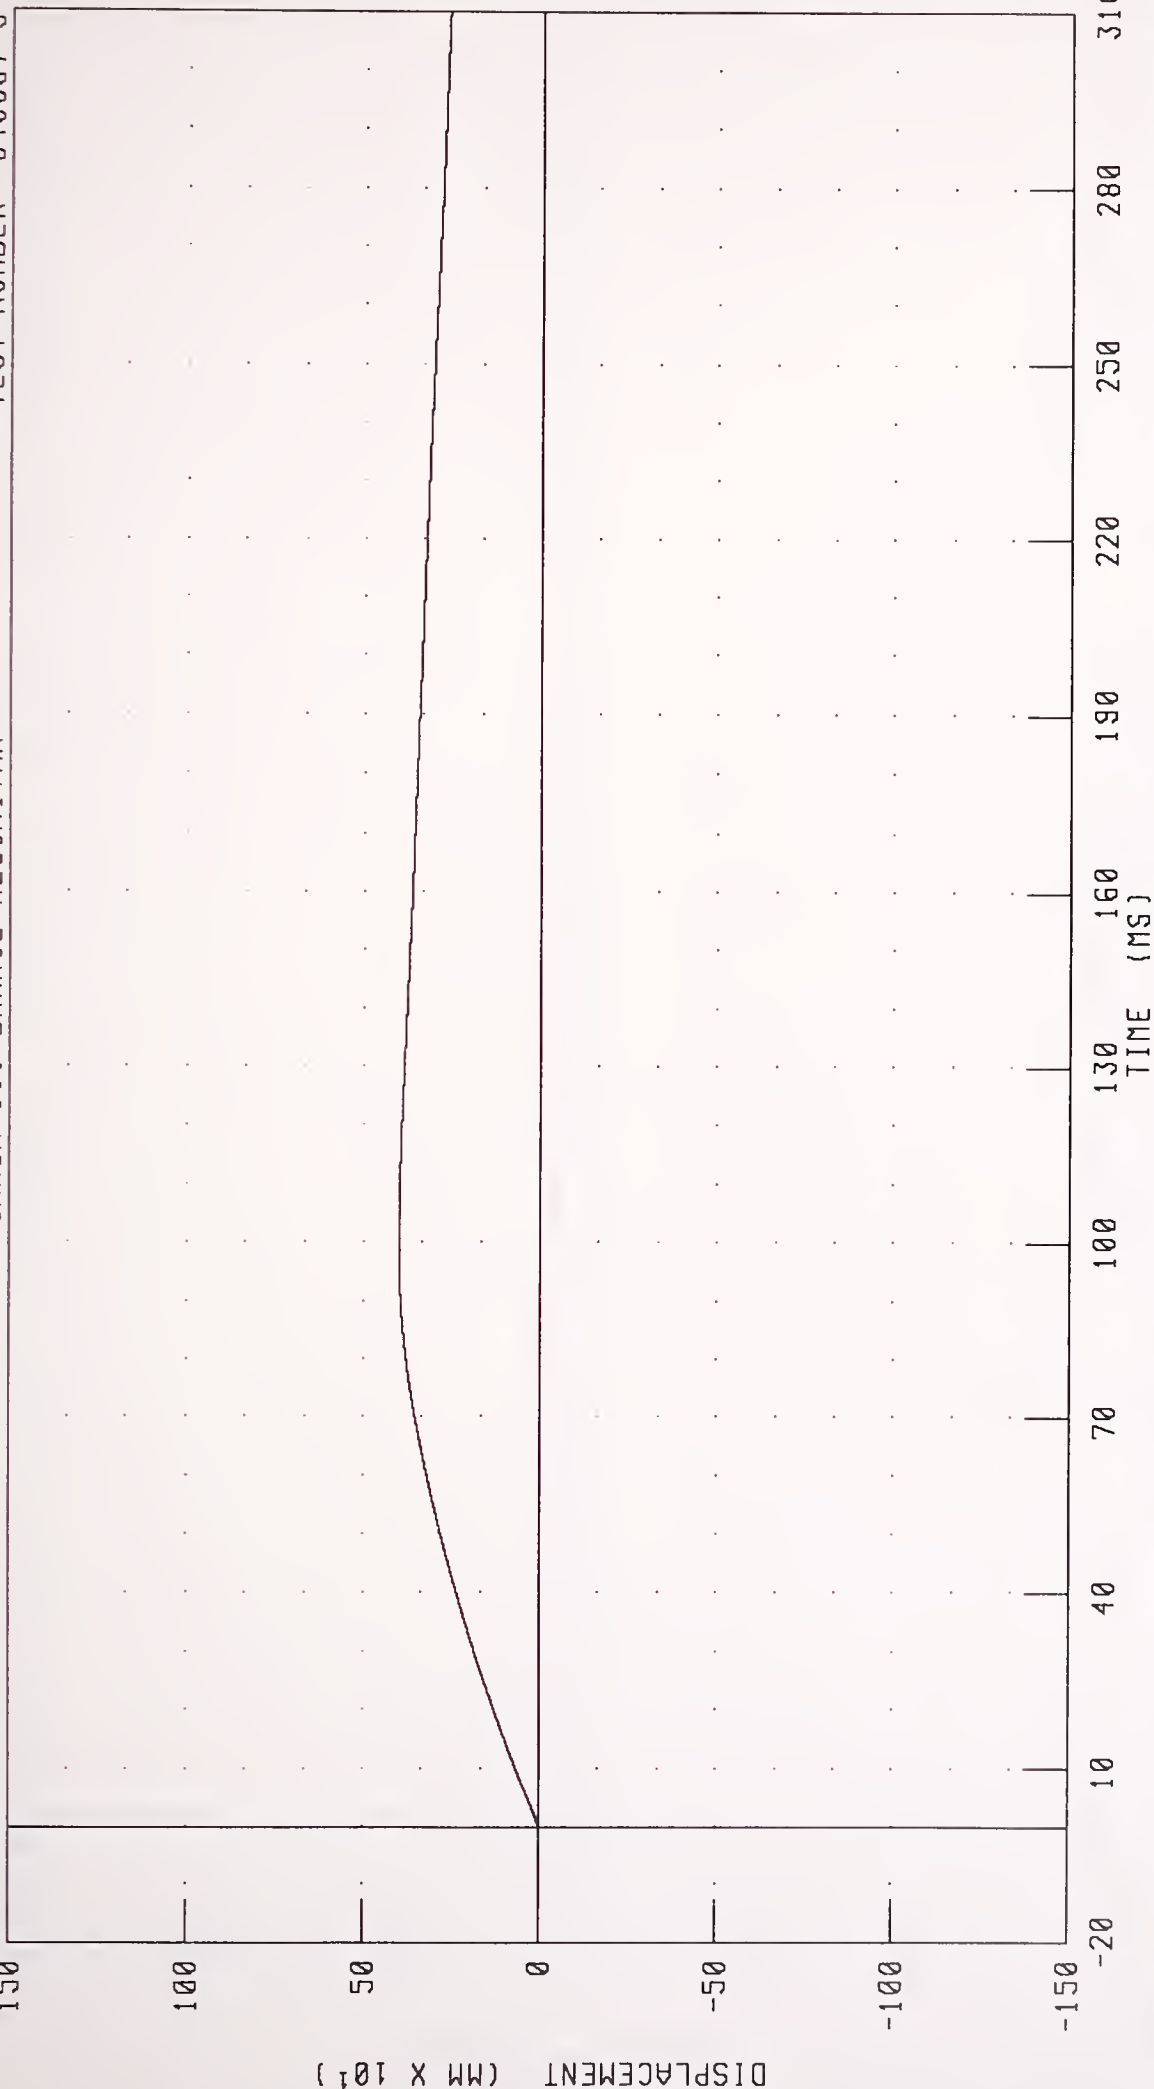
CHANNEL: RRSXD1 FILTER: CH. CLASS 180

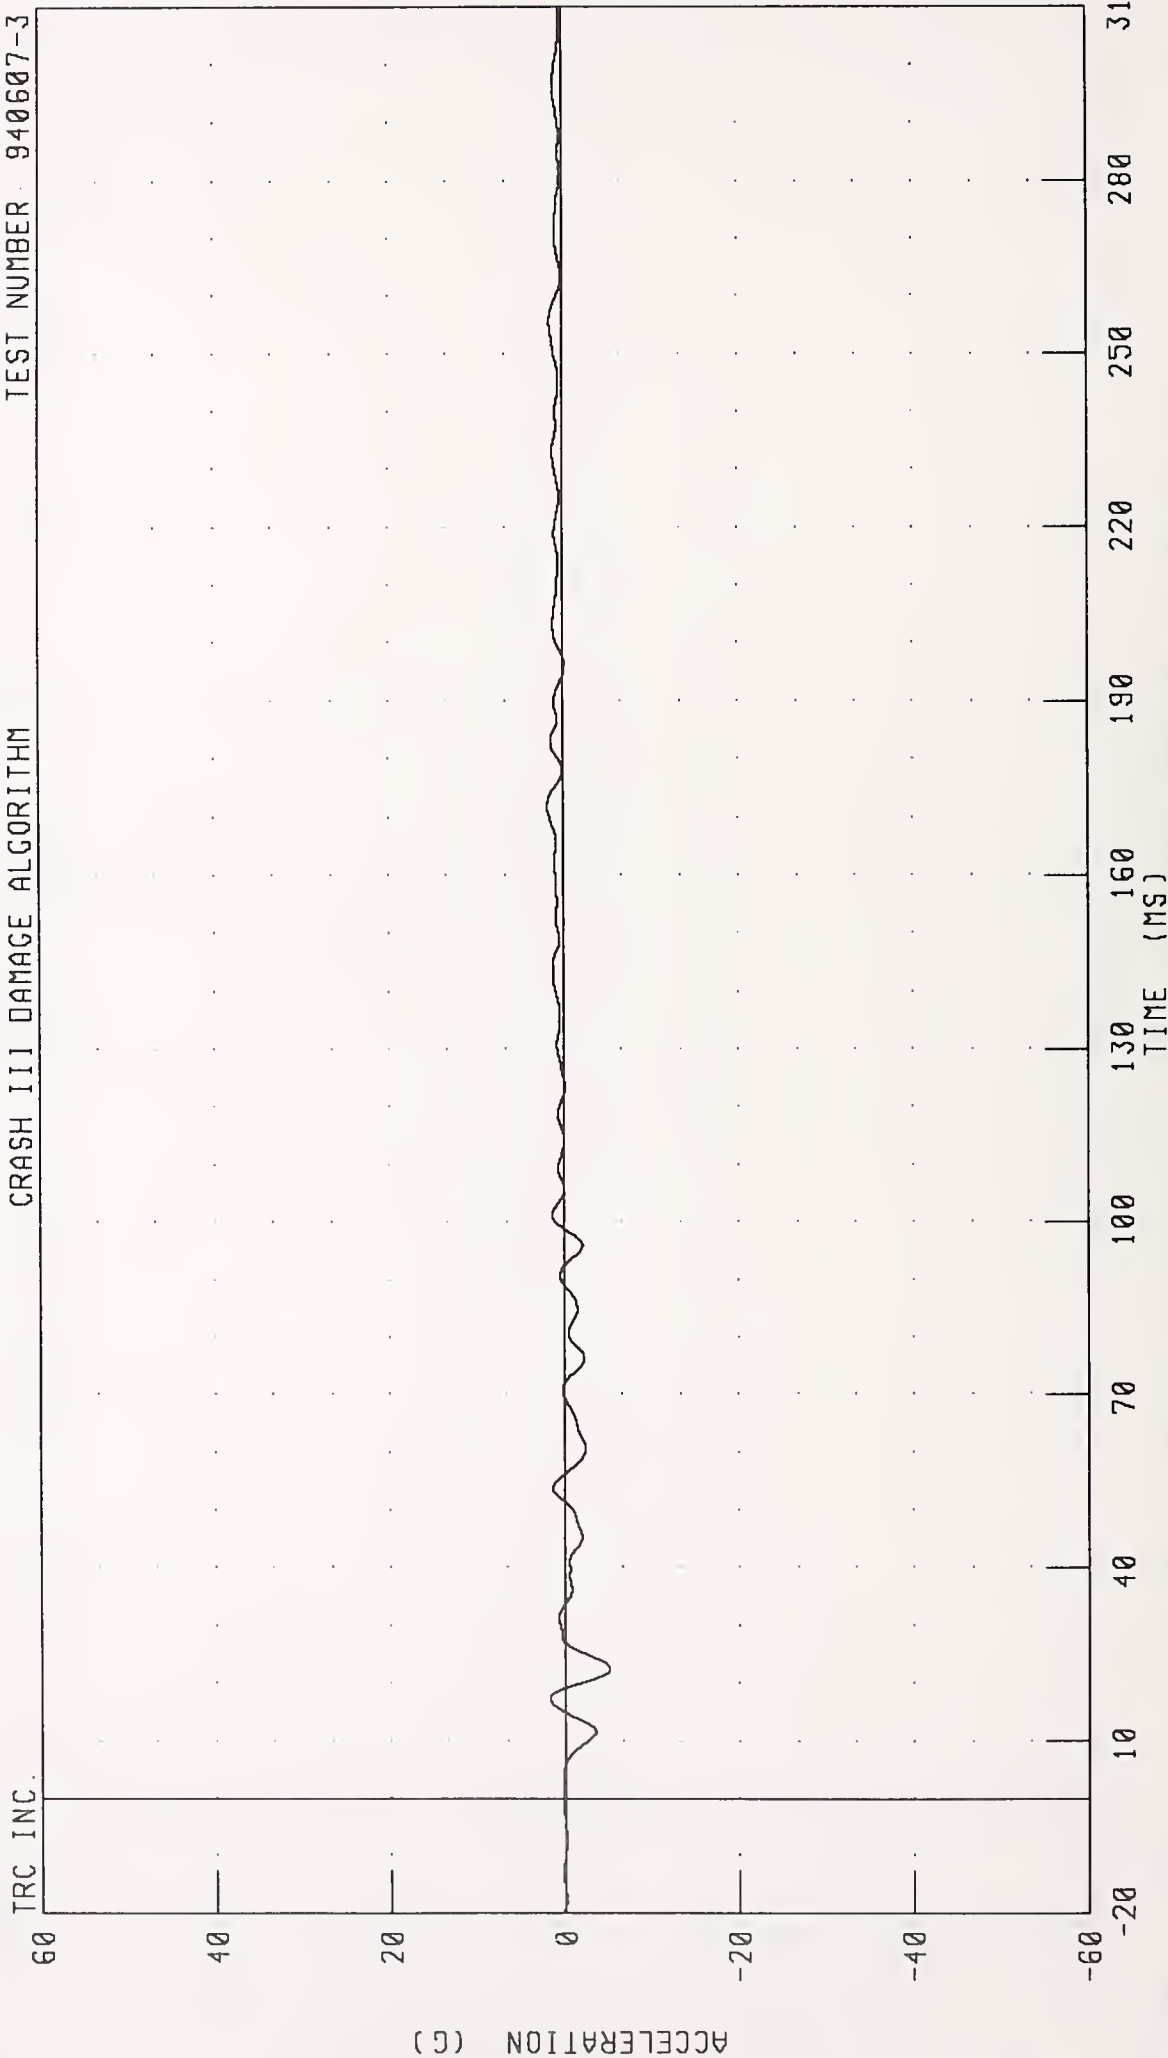
CHANNEL: RRSYG1 FILTER: CH. CLASS 60 PEAK DATA: 1.85 G @ 171.84 MS; -5.14 G @ 22.48 MS

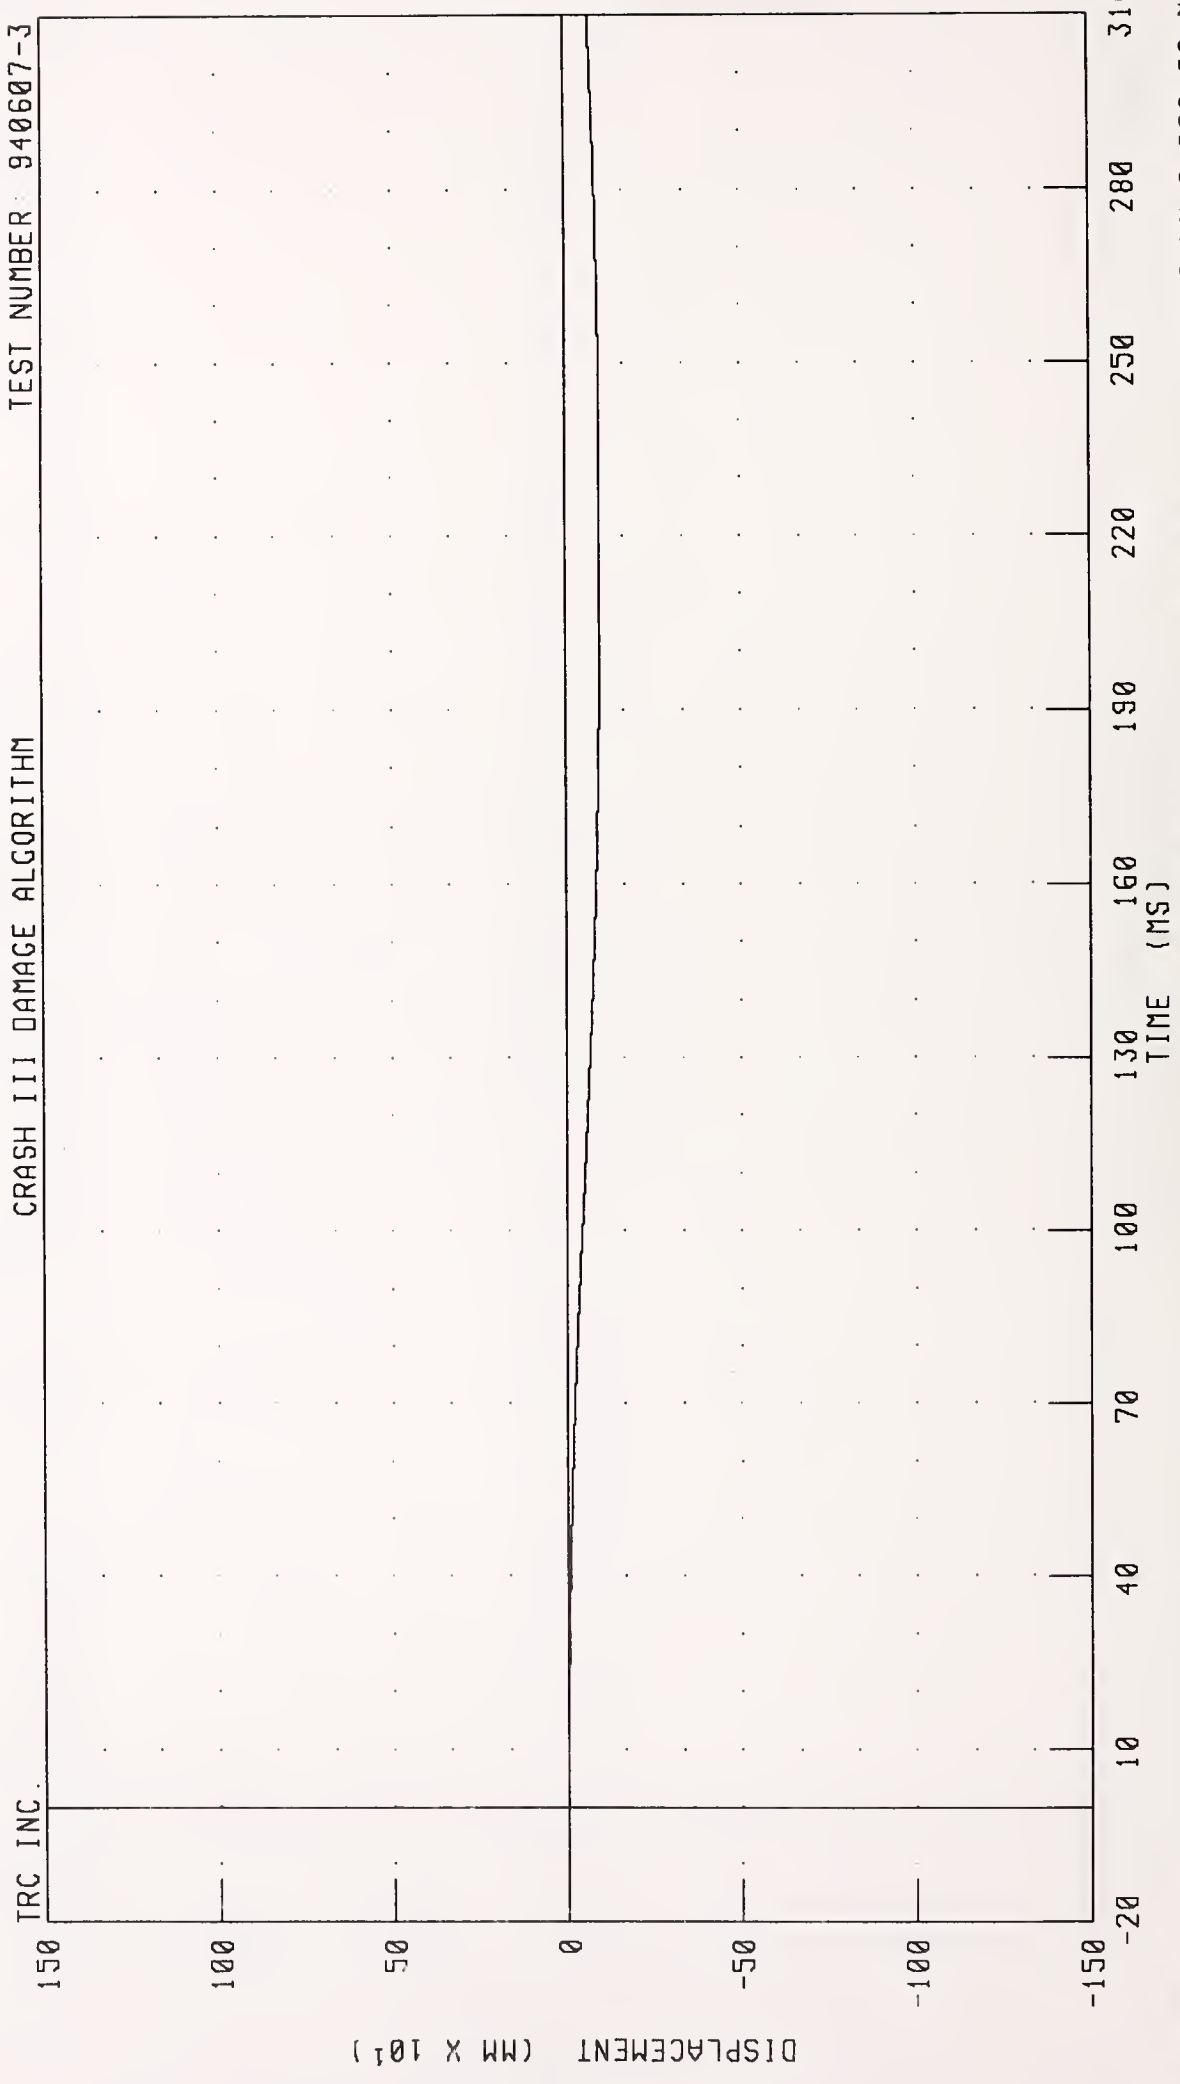
CHANNEL: RRSYD1 FILTER: CH. CLASS 180
